INDOOR AIR QUALITY ASSESSMENT

**East Brookfield Elementary School
410 East Main Street
East Brookfield, Massachusetts**

Prepared by:
Massachusetts Department of Public Health
Center for Environmental Health
Bureau of Environmental Health Assessment
Emergency Response/Indoor Air Quality Program
December 2004

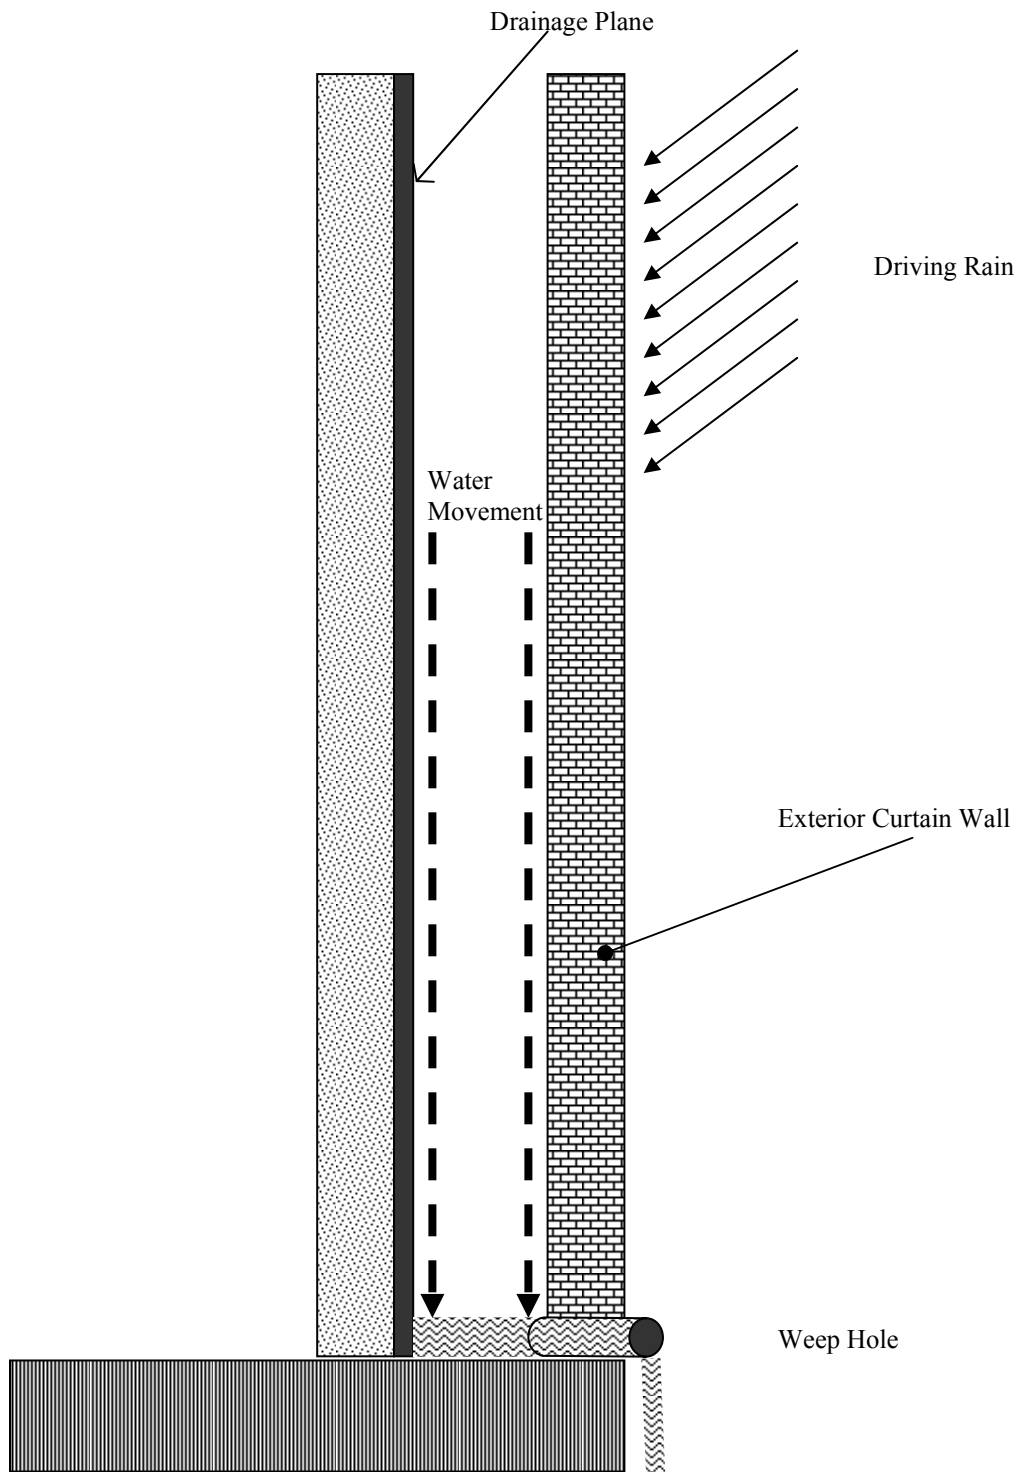
Figure 2

The Function of the Drainage Plane and Weep Holes to Drain Water from the Wall System, Prevent Moisture Penetration into the Interior

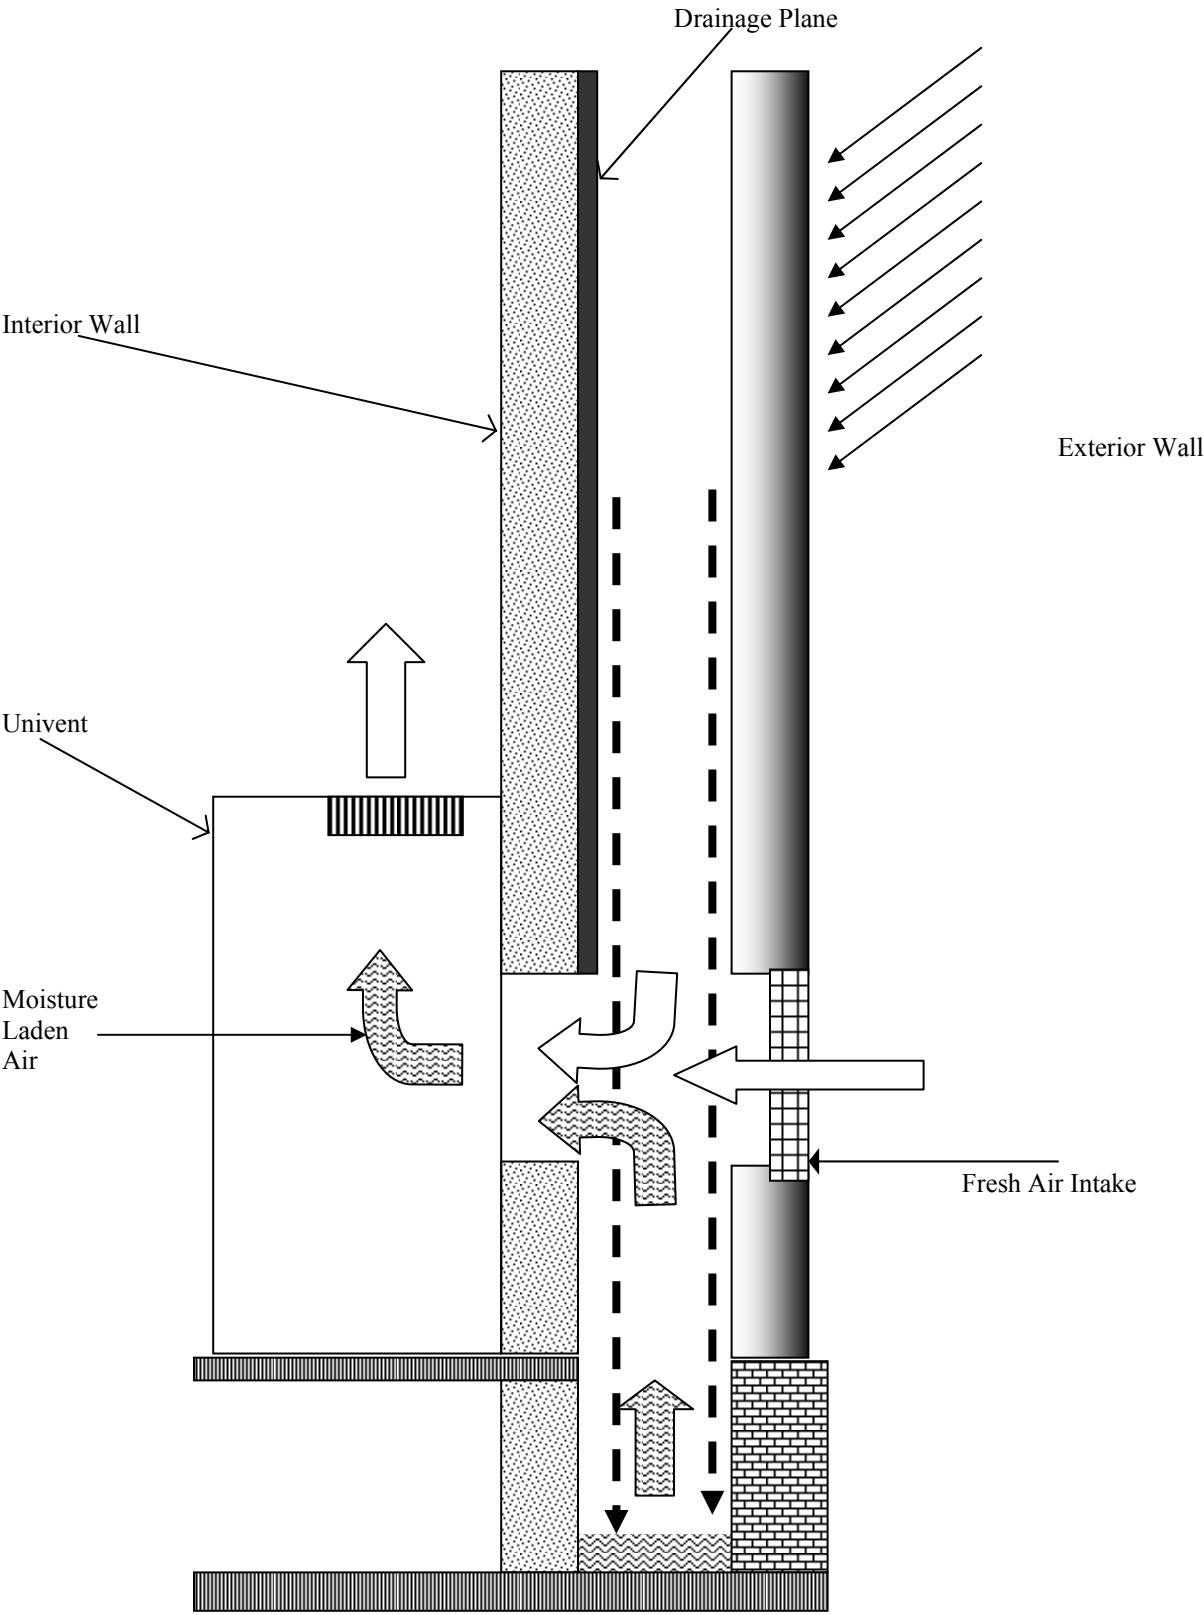
Figure 5
Draw of Moisture From Wall System Into Univent Fresh Air Intake Vent
